Development of a test procedure for sputtered gold as a solid film gear tooth lubricant.

DEVELOPMENT OF A TEST PROCEDURE
FOR SPUTTERED GOLD AS A SOLID
FILM GEAR TOOTH LUBRICANT

MASTER OF SCIENCE IN MECHANICAL ENGINEERING

NAVAL POSTGRADUATE SCHOOL
April 1969

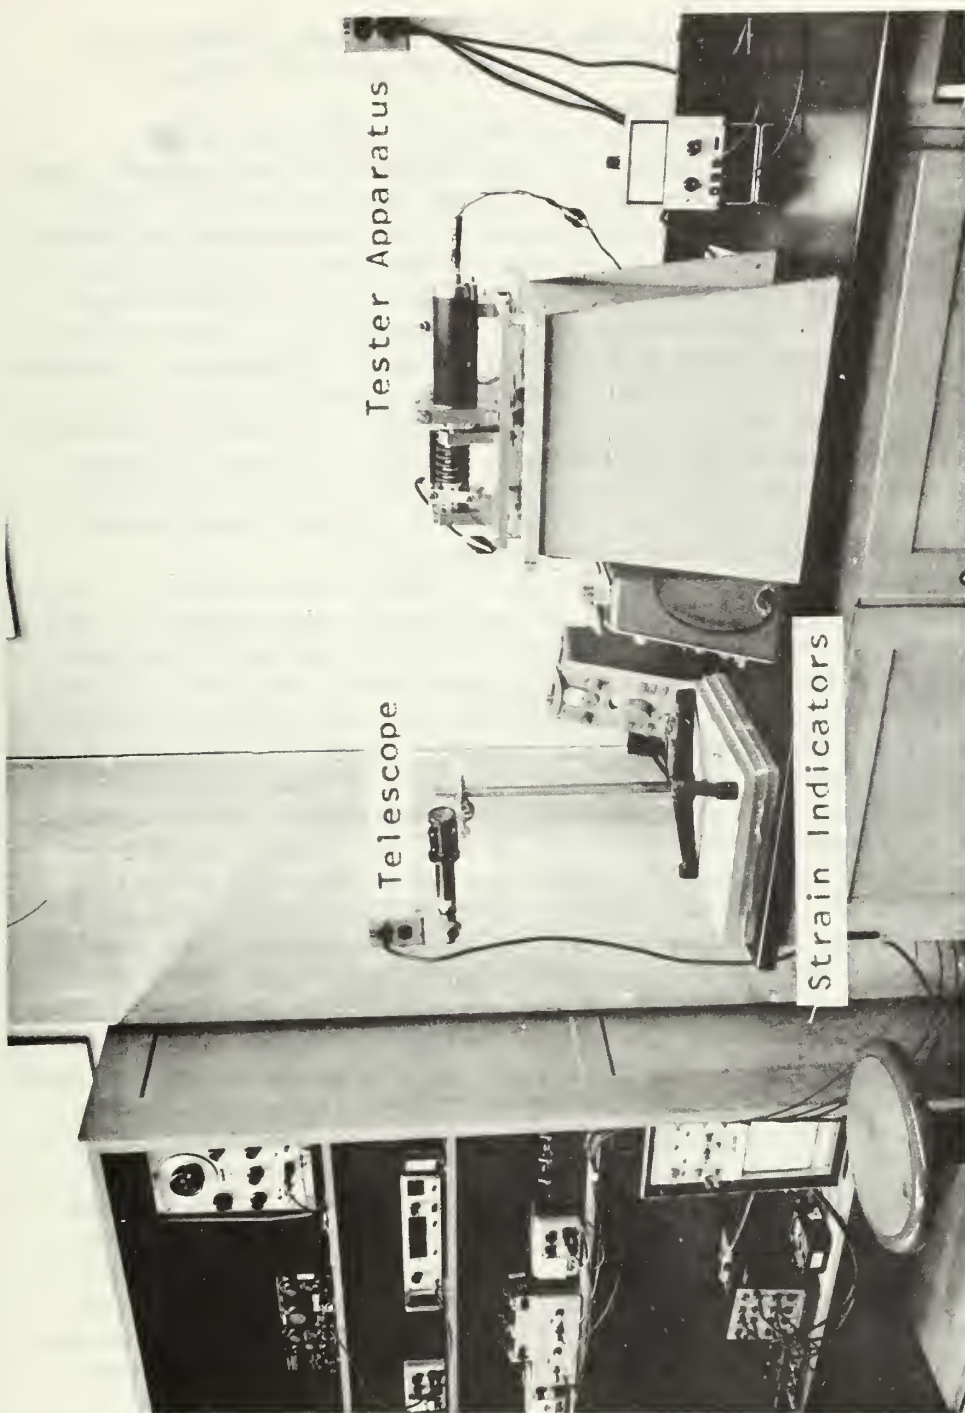
The strain gages mounted on the test gear are in an exposed position; this is particularly true during assembly and disassembly of the apparatus. By the time calibration tests were started, only two of the original six gages were undamaged. These two were connected to form a two-gage bridge with one active gage on a tooth in contact. The set-up for these tests is shown in Figure 7. BLH Type N Portable Strain Indicators were used to measure strains from the torsion bridge and the bridge on the test gear teeth. The instrumented teeth were backlighted with a 12 volt grain-of-wheat bulb so that the point of contact appeared as a dark spot on the line of light that surrounded the teeth. The distance from the point of contact to the root of the instrumented teeth was determined by the graduated, traversing cross-hair of a small telescope. The cross-

FIGURE 7 - TEST SET-UP FOR CALIBRATION OF STRAIN GAGES
TO MEASURE GEAR TOOTH RADIAL FORCES

hair was calibrated by determining the apparent distance between two lines 0.25 inches apart on the test gear.
